TECH BULLETIN

Ricoh* D137/D138 Drawer Failure Prevention & Repair: Belt Tensioner Installation

OEM: D1367543 NATT: 02042007

MODELS: PRO C5100S/PRO C5110S/ MP C6502SP/ MP C8002SP

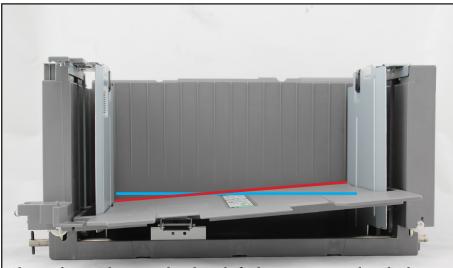
PROBLEM: If a bottom tray plate is slanted, it is likely the belt that sets the tray bottom plate height has lost elasticity from premature wear and slipped off the corresponding tooth on the gear. This is often observed early in the life of the belt. Various methods to address this issue, such as adjusting or replacing the belt or even the entire drawer, have not been successful because the replacement OEM belts are also prone to the same failure.

PREPARATION: Position your tray bottom plate on a level surface. The tensioner will be positioned just above the white wheel axle so it presses against the belt (see figure 1). Prepare the area by using a shop towel to wipe away any dust or grime.
