## Ricoh\* D137/D138 Drawer Repair: Belt Tensioner Installation

OEM: D1367543 NATT: 02042007

MODELS: PRO C5100S/PRO C5110S/ MP C6502SP/ MP C8002SP

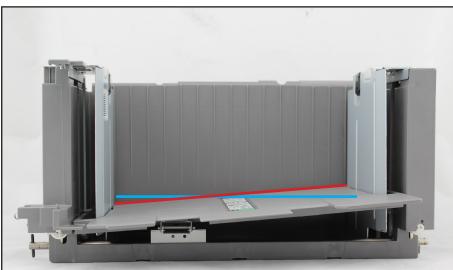
**PROBLEM:** If a bottom tray plate is slanted, it is likely the belt that sets the tray bottom plate height has lost elasticity from premature wear and slipped off the corresponding tooth on the gear. This is often observed early in the life of the belt. Various methods to address this issue, such as adjusting or replacing the belt or even the entire drawer, have not been successful because the replacement OEM belts are also prone to the same failure.

Above, the tray bottom plate has shifted to a severe angle, which would result in paper feed problems and downtime.

**SOLUTION:** Installing this belt tensioner, available exclusively from NA Trading and Technology, in your D137/D138 drawers will keep the belt tight against the gear. This will result in a belt that won't slip and the elimination of a preventable service call.
