## Toner Sweep Rebuild Kit

**NATT #:** 02036058

### For use in:

AF 1035/ AF 1045/ AF 2035/ AF 2035e/ AF 2045/ AF 2045e/ AF 3035/ AF 3045/ AF MP3500  
AF MP4000/ AF MP4001/ AF MP4500/ AF MP5000/ AF MP5001/ AF SP8200DN/ 2235/ 2245/ 2535  
2545/ 4035/ 4045/ 8035/ 8045/ 9040/ 9050/ 9240/ 9250/ MLP150DN/ 3502/ 3532/ 4502/ 4532  
DSm635/ DSm645/ DSm735/ DSm745/ 5635/ 5645/ LD035/ LD040/ LD045/ LD050/ LD135/ LD140  
LD145/ LD150/ LD235/ LD245/ LD335/ LD345/ LPN150DN

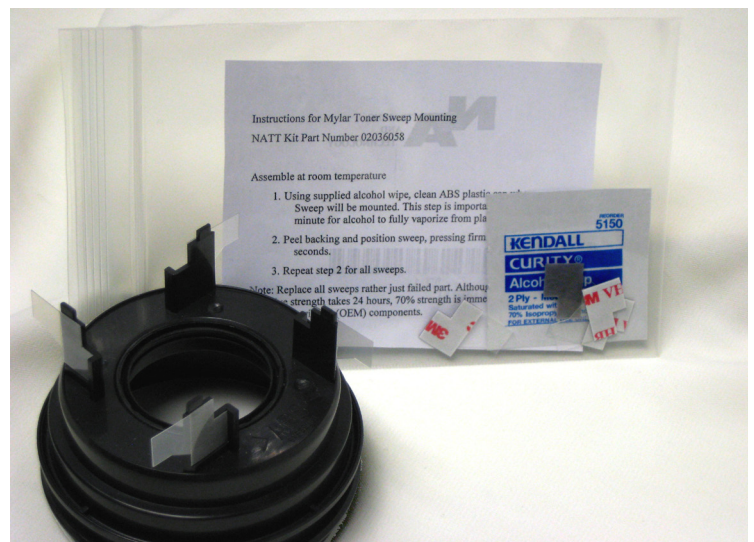
**4 - A2323243 Toner Sweeps**

The Mylar (OEM #: A2323243) toner sweeps peel off the hopper cap (OEM #: A2323240) and foul the toner supply system.

Failure of adhesive holding toner sweep to cap.

Use a very high bond (VHB) adhesive on the toner Mylar. VHB is a stronger adhesive, which when applied to a clean surface, eliminates the Mylar peeling off the cap. This results in fewer unscheduled service calls, an extended toner hopper life as well as an increase in customer satisfaction and improved service profits.
